JAGUAR XK120

JCNA CONCOURS JUDGING GUIDE

CORRECTIONS AND UPDATES

This document contains “corrections and updates” made to the XK 120 JCNA Concours Judging Guide
First Printing in September 2018, approved for “trial use” during 2018 Concours season at the
60th Annual General Meeting (AGM), San Antonio, Texas, March 21 – 25, 2018

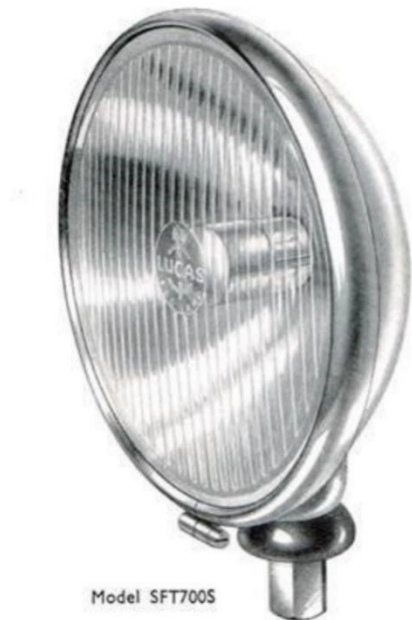
C.2988 SFT700S vertically fluted fog lamp lens for alloy and early steel-bodied cars from 1949 to Nov 1951-Jan 1952 build date. Photo by Lucas Master Catalog 713 (Jan 1951)

- From 1949 to Nov 1951-Jan 1952 cars, ONLY Lucas SFT.700S with 'vertical fluted' lens is correct.
- From Jan 1952 onwards, ONLY Lucas SFT.700S with 'block type' lens is correct.

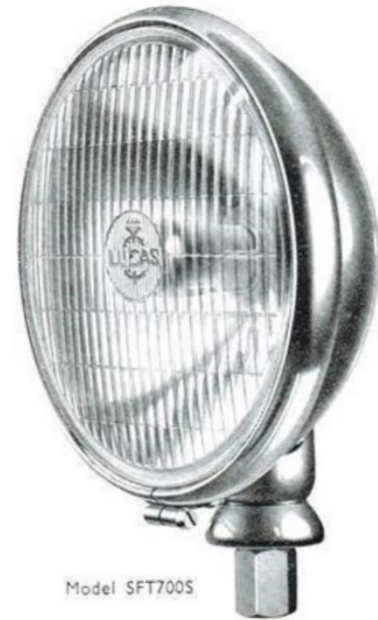
C.2988 SFT700S block type (vertical and horizontal lines) fog lamp lens for later steel-bodied cars from Jan 1952 build date onwards. Photo by Lucas Master Catalog 713A (Dec 1952)

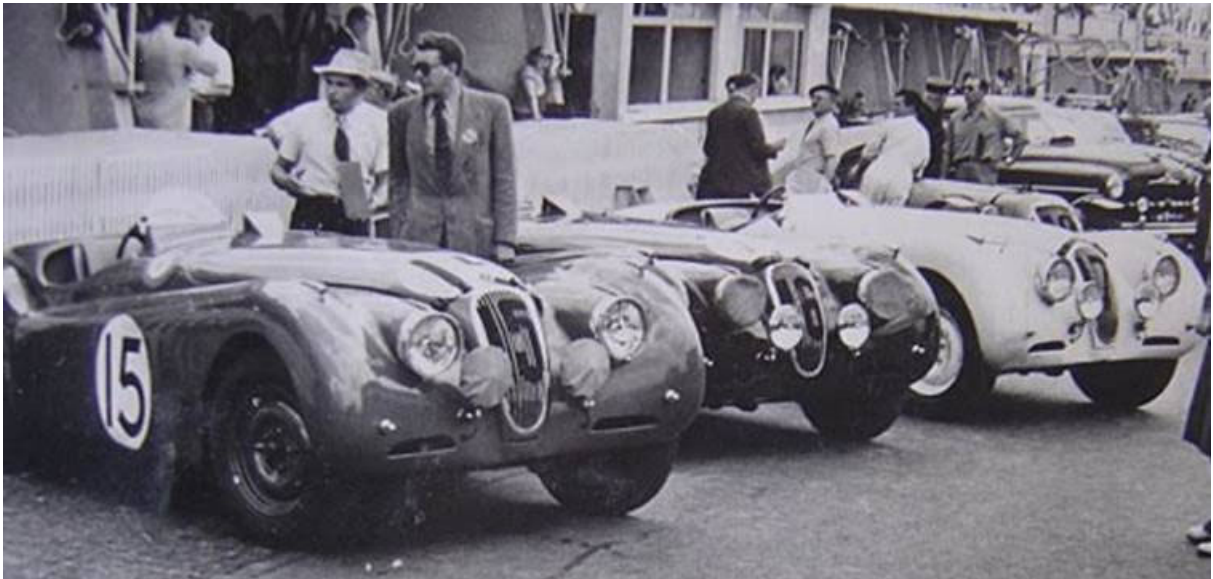
The three 'works team' XK 120's (June 1950) Le Mans 24-hour race, showing their factory fitted fog lamps, mounting brackets and black plastic sleeve covered wiring cables routed through the front wings. Photo provided by JDHT.

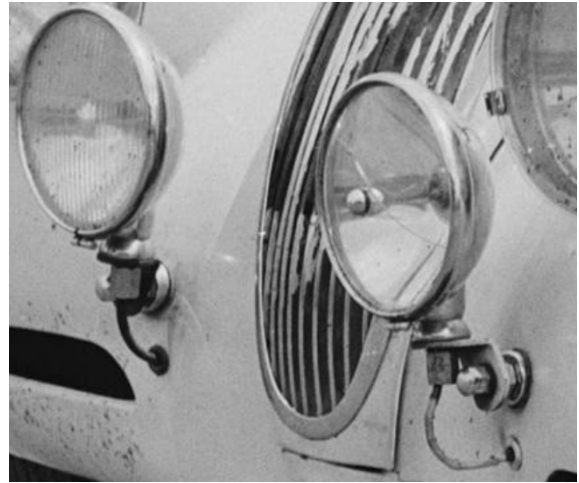
XK120 with front bumper-bars removed for racing, showing the original mounting brackets correctly mounted, and the black plastic sleeve covered cables passing through rubber grommets and holes drilled just under each light.

- Any entry with 'driving/long range lamps and clear plain lens' (like the left side driving lamp pictured above) are NON-AUTHENTIC.
- Factory supplied C.2985/86 (right/left side) fog lamp mounting brackets are 'L' shaped one-piece steel plate attached just behind the dome nut, mounted to the threaded extensions, used to attach the bumper spring blades. (pictured above right)

- Factory installed fog lamps have black plastic sleeve covered cables passing through rubber grommets and holes drilled just under each lamp. (pictured above right)

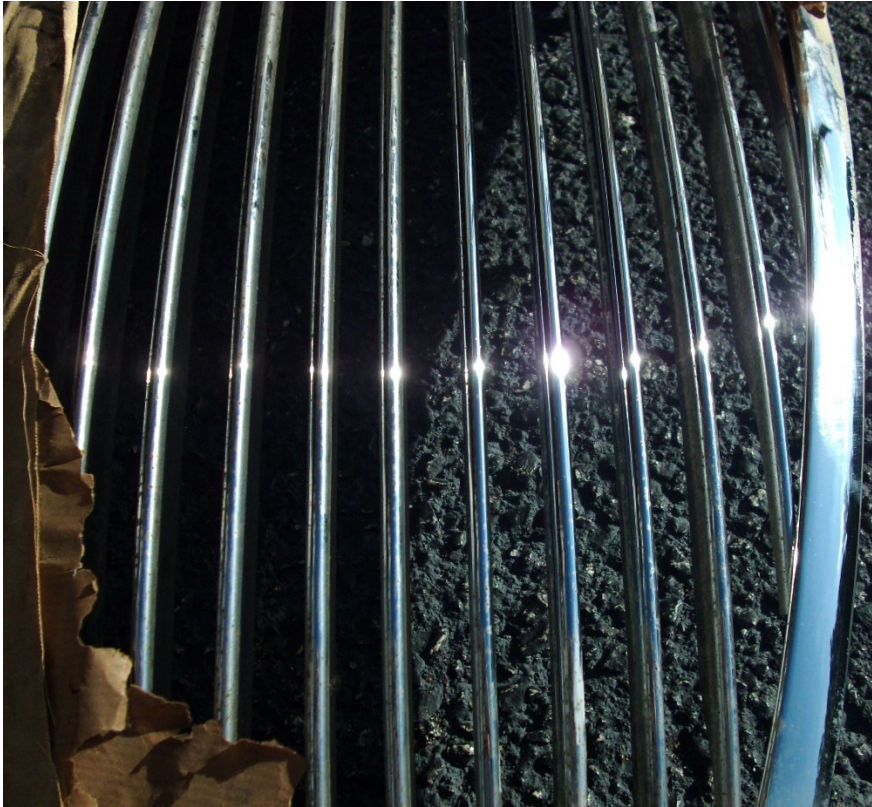
Early cars (up to about 1951) have grille vanes with raised-flutes on leading edges.

- The chrome-plated brass Grille Assembly should have 13 Vanes.
- The vanes had a raised-flute on the leading-edge profiles for earlier XK120s up to about 1951, and thereafter for later XK120s the vanes were no longer fluted.

NOTE: There are competing views whether the later vane profile is the result of new tooling, and thus an exact demarcation, or whether it is the result of tooling gradually wearing out, and thus no exact demarcation. As the exact demarcation for this vane profile change has not been established at present, for judging purposes, either or intermediate profiles are accepted as being authentic, but any one grille should have matching vane profiles.

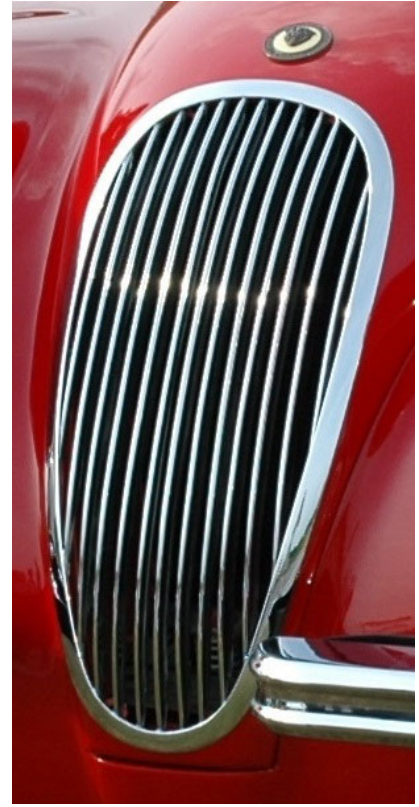
Later grille vanes have rounded leading edges.

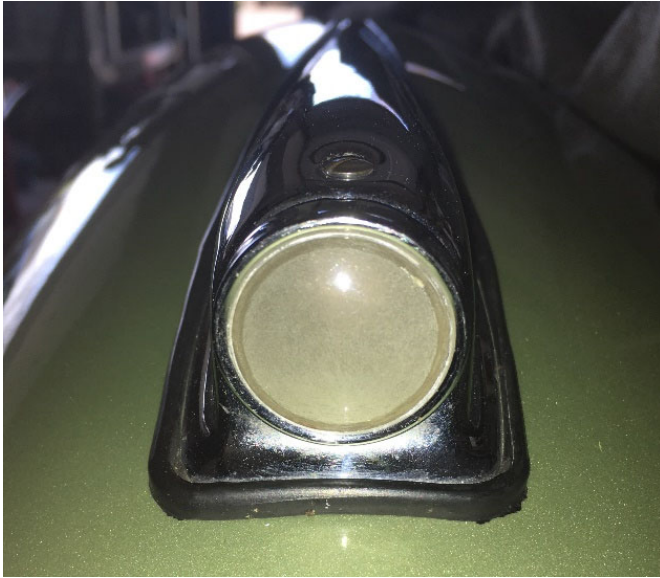
'Original' LUCAS MODEL 490 side lamp with plain, slightly convex, opaque/white lens.

- For all steel-bodied OTS chassis nos. 670185 to 672926 (March 1950 to Oct 1952), chrome-plated sidelamps housings (casing) are fitted. The interior lamp assembly (Lucas 52150/A-490) has a plain, slightly convex, opaque/white lens.
- The chrome sidelamp housings have a rubber seal (mounting pads). (pictured above left)
- The interior assemblies are fastened to their housings by chrome plated raised countersunk headed, slotted screws.
- Replacement, and later Lucas interior lamp assemblies have a clear molded glass lens with LUCAS 490 ENGLAND lettering (pictured above right), and include a thin rubber 'O-ring' that fits between the lens' chrome rim and the sidelamp housing

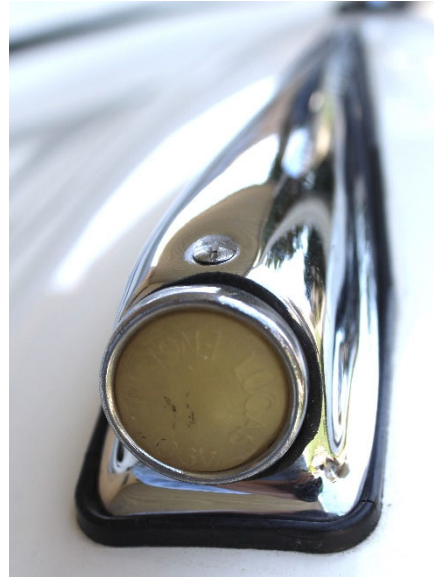
*'Original' LUCAS MODEL 490 side lamp
NOTE: over time, the lens can turn a 'yellowish' color which is acceptable.*

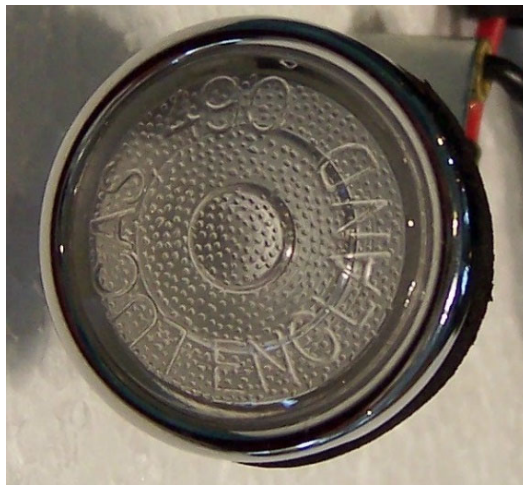
'Replacement' side lamp lens, marked 'LUCAS 490 ENGLAND' with basic bullseye/ring pattern.

NOTE: Due to the scarcity of serviceable plain convex lens, either of the two pictured/described side lamp lens' are acceptable for judging purposes.

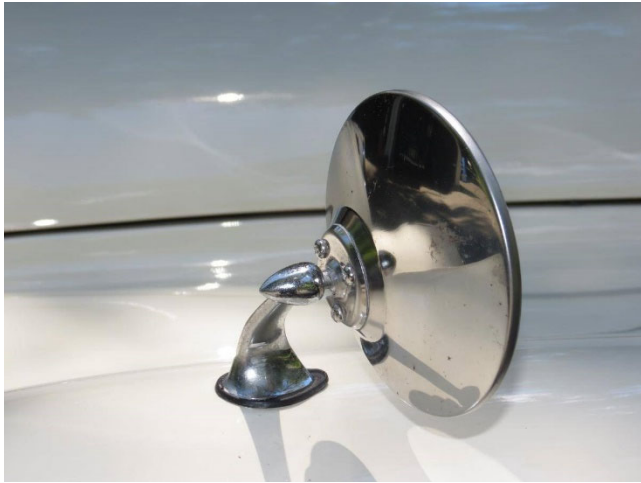
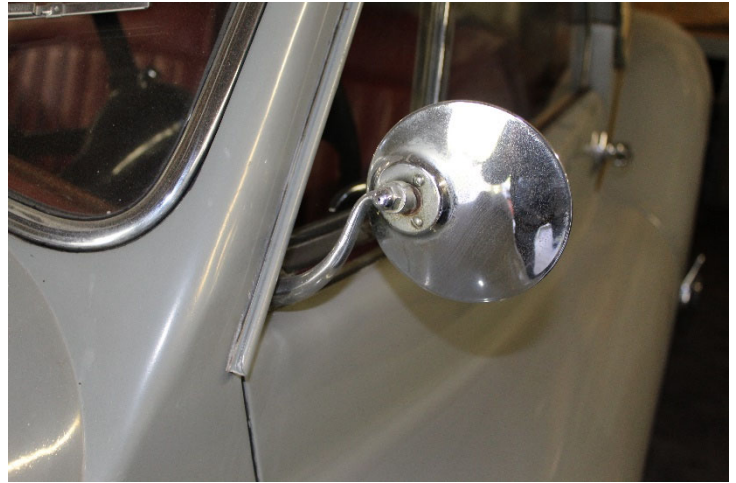
NOTE: There is no evidence that any XK120s were fitted with external rear vision mirrors — fender/wing or door mounted — by the Jaguar factory as either standard equipment nor as an optional extra. The pictured Lucas 406 style fender/wing and door mounted mirrors were however often fitted/available as original/optional equipment to a number of other period British cars, but not to any XK120 cars.

- If an XK120 entry has external rear vision mirrors fitted:
 - Any period of external rear vision mirror, available during 1949 to 1954 is allowable without penalty but must be a ‘wing mirror’ design. (see pictures above)

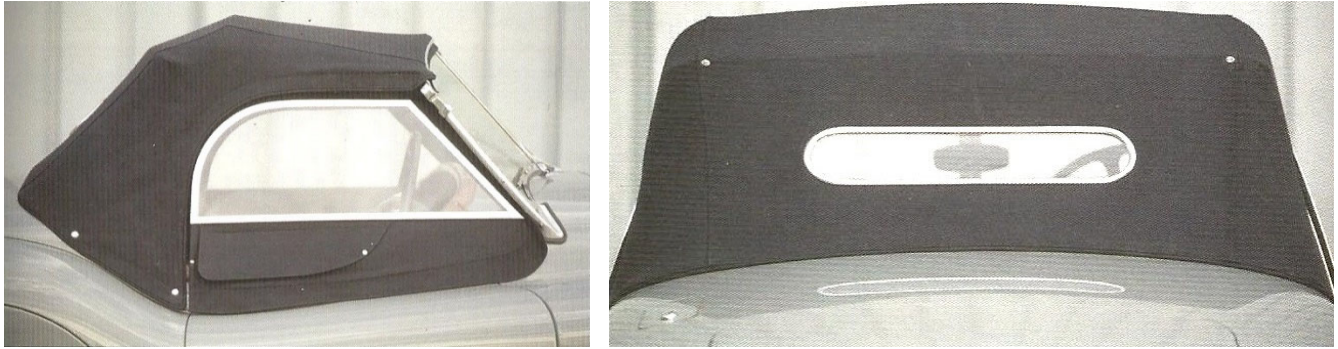
- OTS chassis nos. 670185 to 671097 (April 1950 to February/March 1951), are fitted with a BD.3824 'short hood' cloth assembly with a non-zippered backlight assembly, mounted onto the chrome-plated hoodsticks assembly.
- The hood should have a proper canvas flap below the canopy rail, covering the top chrome frame of the windshield and extending over the outer stanchions.
- The hood should have two 'Durable-Dot' snap fasteners on the body immediately behind the doors on both sides.
- The hood should be the proper style and length.
- The hood should have the proper back curtain and 'wider backlight' assembly.
- **NOTE:** SEE INTERIOR SECTION 'HOODSTICKS ASSEMBLY'

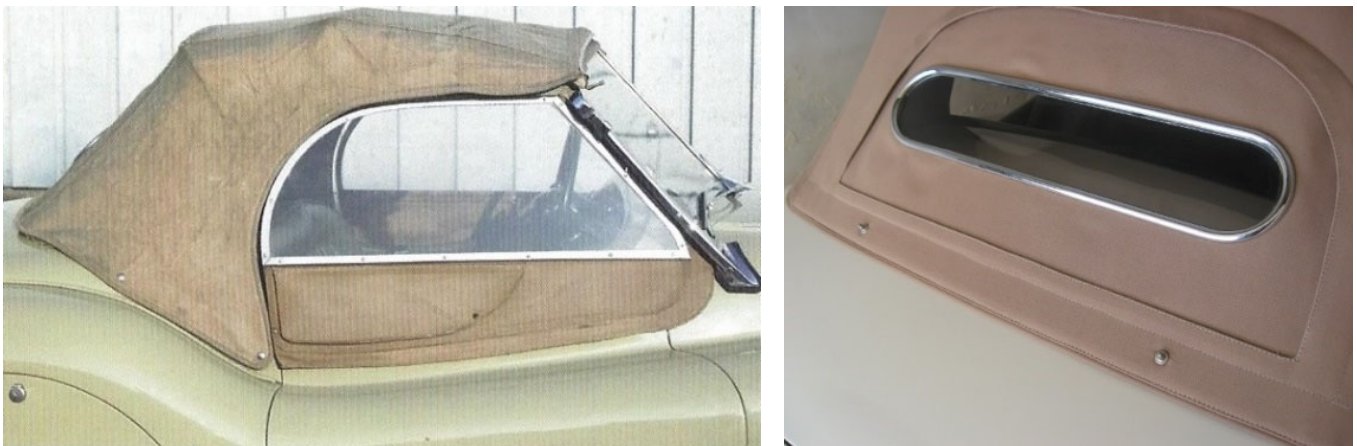
- OTS chassis nos. 671098 to 673395 (February/March 1951 to January 1953), steel-bodied cars are fitted with a long hood cloth assembly complete with backlight/curtain and single zipper fastener, mounted onto the greenish/grey paint hoodsticks assembly.
- The teardrop retainer hooks were moved rearwards by 5-inches.
- The hood should have a proper canvas flap below the canopy rail, covering the top chrome frame of the windshield and extending to the outer stanchions.
- The hood should have two 'Durable-Dot' snap fasteners on the body immediately behind the doors on both sides.
- The hood should have the proper back curtain and backlight assembly.
- The hood should have two 'Lift-the-dot' posts directly below the rear curtain.
- **NOTE:** SEE INTERIOR SECTION 'HOODSTICKS ASSEMBLY'

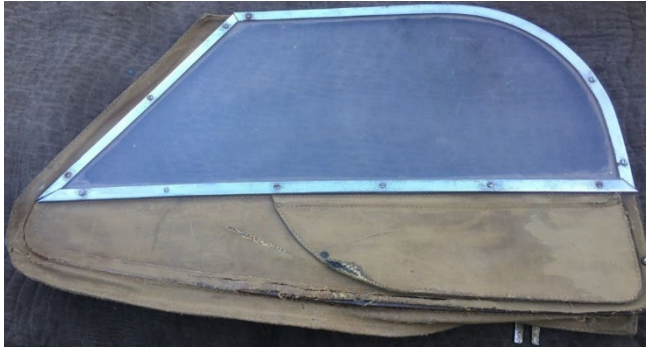
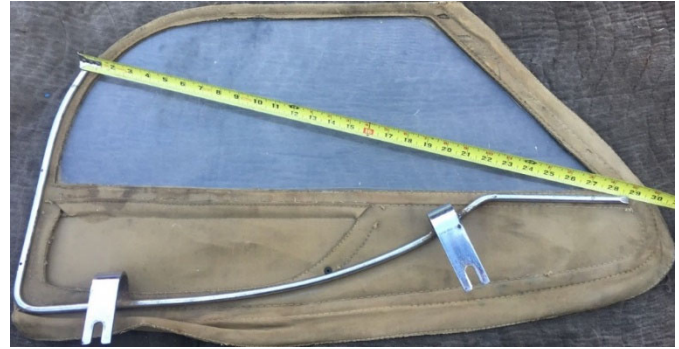
- OTS chassis nos. 670185 to 671195 (March 1950 to May 1951), BD.3372/73 Style-1 side curtains are fitted for the BD.3824 ‘short hood’ cloth assembly.

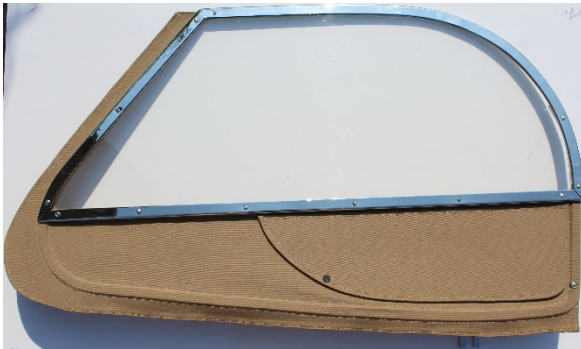
- OTS chassis nos. 670185 to 671097 (April 1950 to February/March 1951), BD.4492/93 Style-2 side curtains are fitted for the BD.5866 hood cloth assembly.

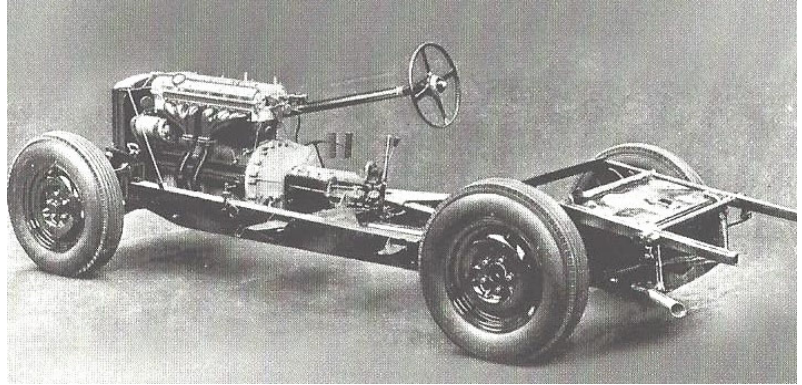
Factory photo of a chassis with angled single tail pipe and chrome tip. JDHT.

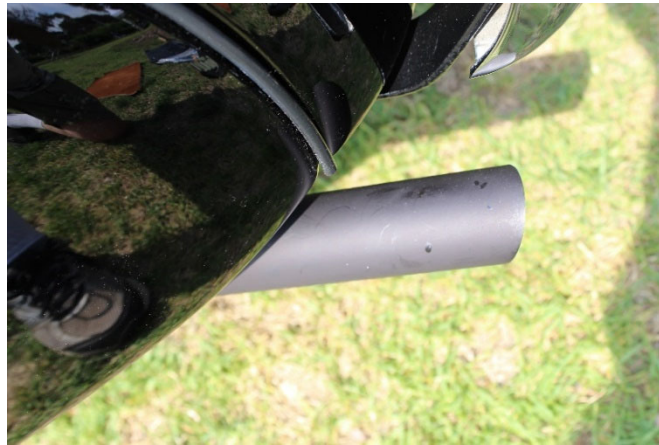
OTS/FHC/DHC single exhaust system.

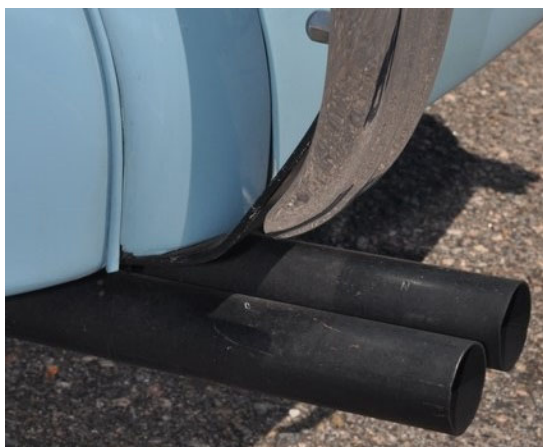
Dual exhaust system.

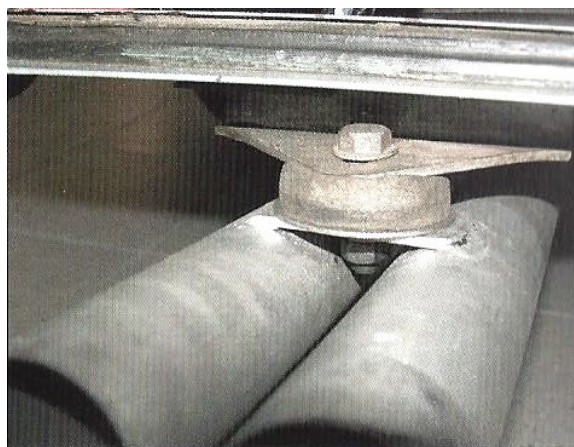
Dual exhaust mounting.

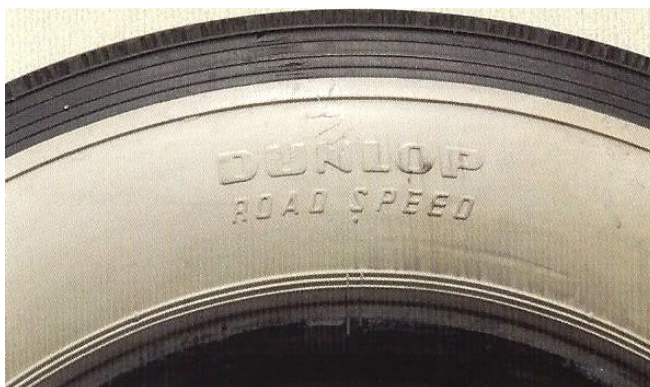
White sidewall tire. photo © Copyright 2002 by Urs Schmid.

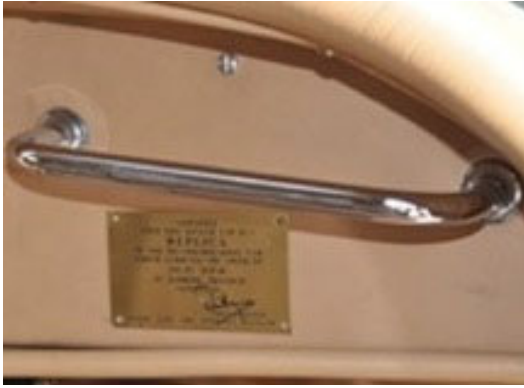
Early steel-bodied car.

- A new design BD.4660 Grab Rail being introduced from the first steel bodied OTS 670185 onwards, was mounted directly onto the facia. These replaced the earlier BD3442 Grab Rail mounted from under the scuttle top, as had been used on all aluminum bodied XK120s.
- The steel bodied BD.4660 was most commonly found to be chromium plated (including its mounting escutcheons)
- For a brief period, BD.4660 Grab Rails were supplied painted a greenish-grey (possibly aligning with the period of Nickel use restrictions) and indeed is sometimes reported in exceptional cases to be found painted in body color.

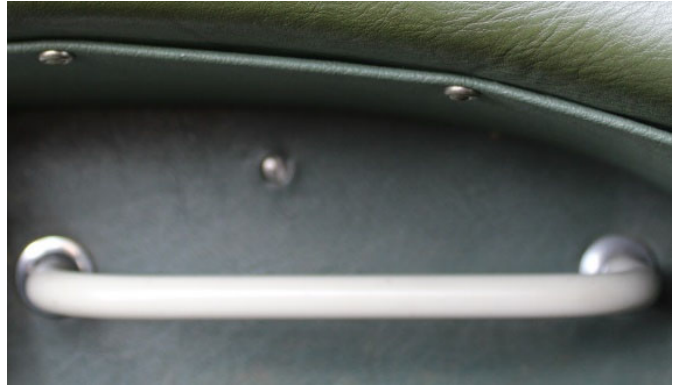
*Later steel-bodied cars grab rail bar painted greenish/grey.
Photo © Copyright 2002 by Urs Schmid.*

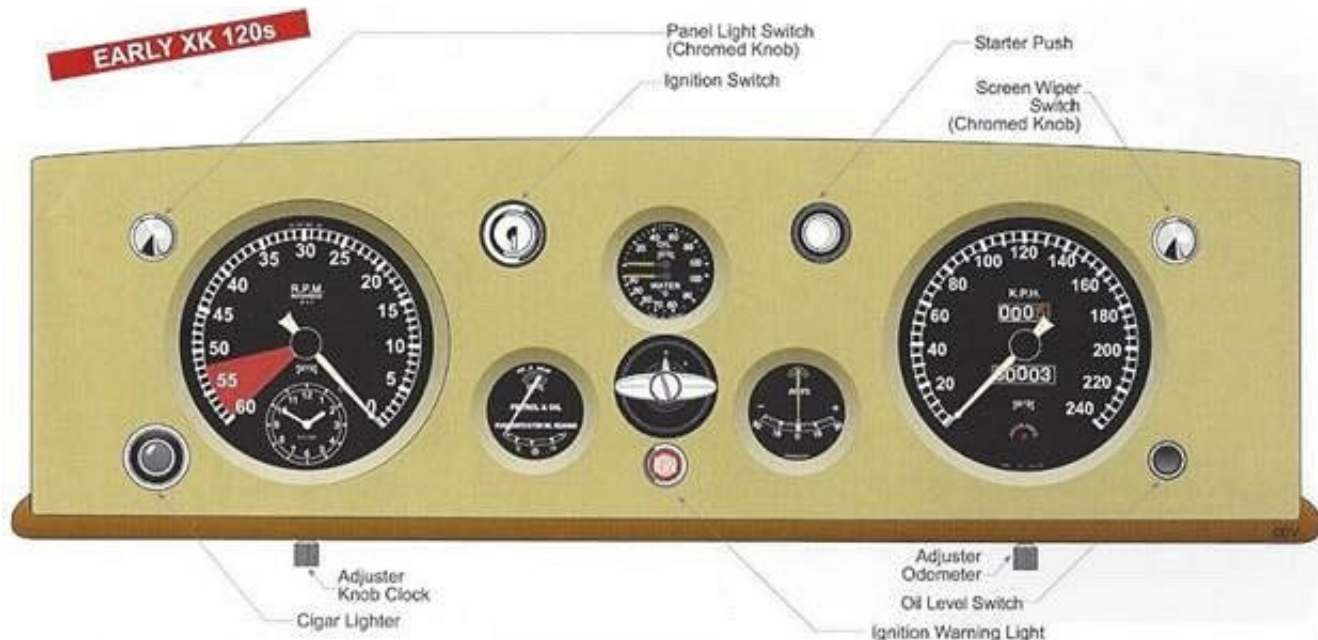
Instrument Panel Assembly illustration used by permission of Bernard Viart, from his book XK 120 Explored (published by PJ Publishing Ltd). See text and NOTES below for detail and exceptions.

- **REV.COUNTER and ELECTRIC CLOCK.** Left Side as shown, and unchanged for all LHD steel bodied XK120. (**NOTE:** RHD cars can often be found with Rev. Counter on RHS and Speedometer on LHS). Always the same SMITHS counter-clockwise unit with its 5200 RPM red-line, and an included small 12-hour electric clock.

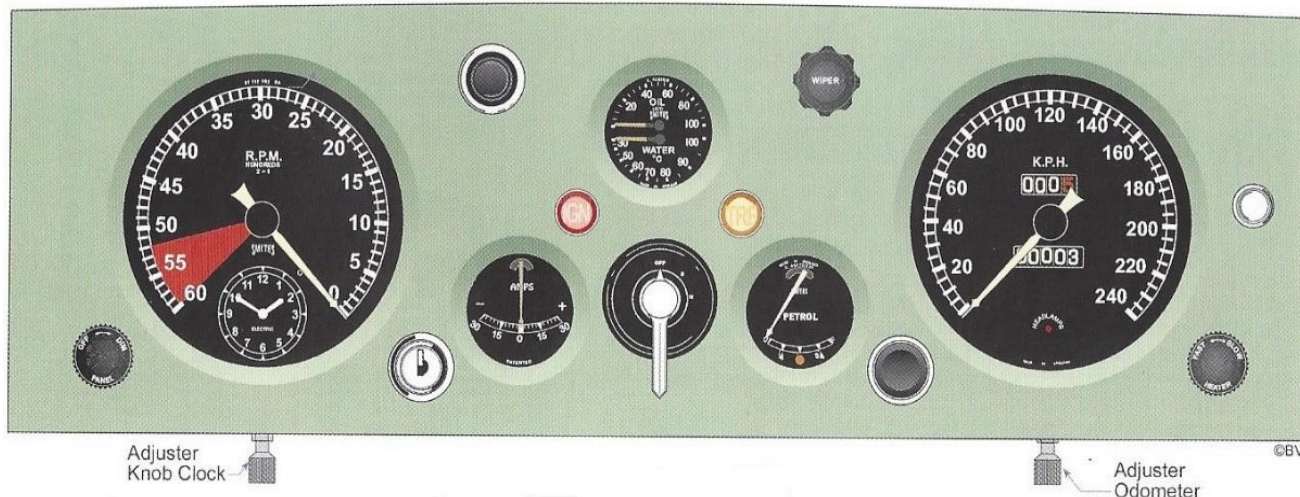
Instrument Panel Assembly illustration used by permission of Bernard Viart, from his book XK 120 Explored (published by PJ Publishing Ltd). See text and NOTES below for detail and exceptions.

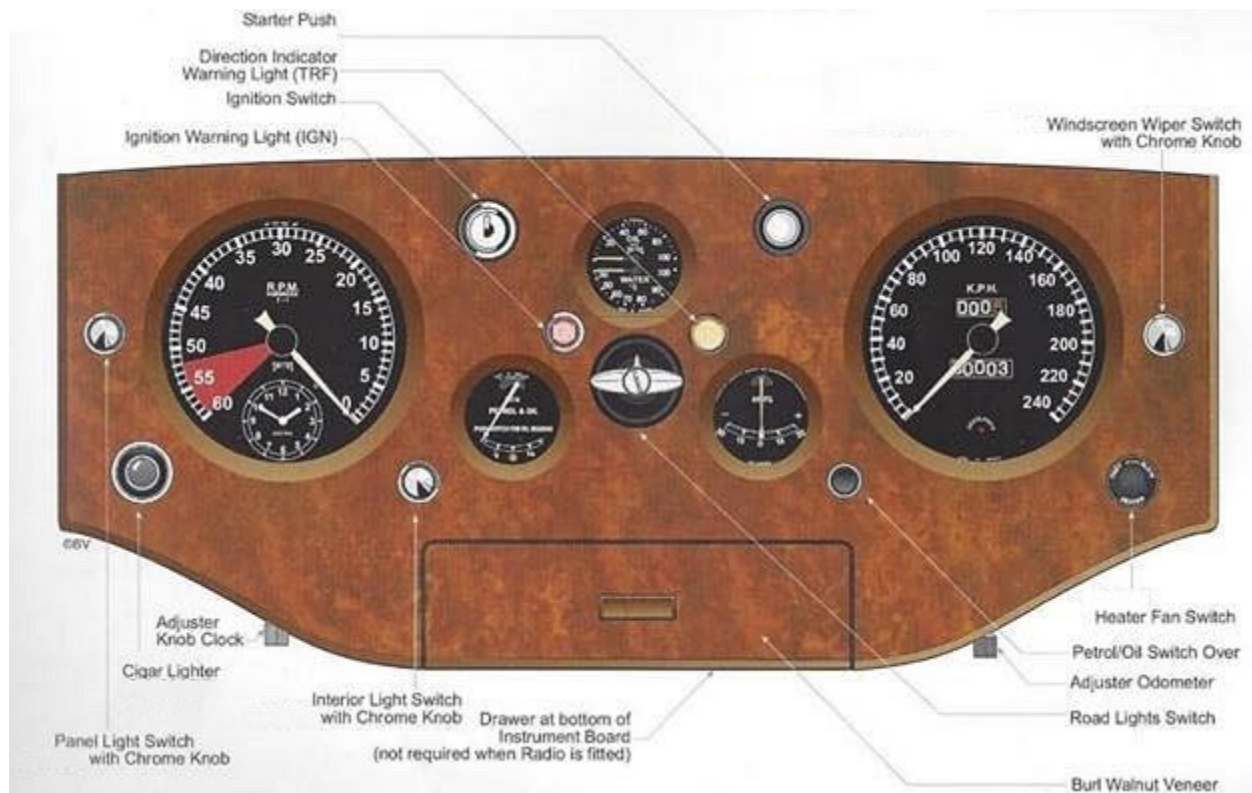
*Instrument Panel Assembly illustration used by permission of Bernard Viart, from his book XK 120 Explored (published by PJ Publishing Ltd).
See text and NOTES below for detail and exceptions.*

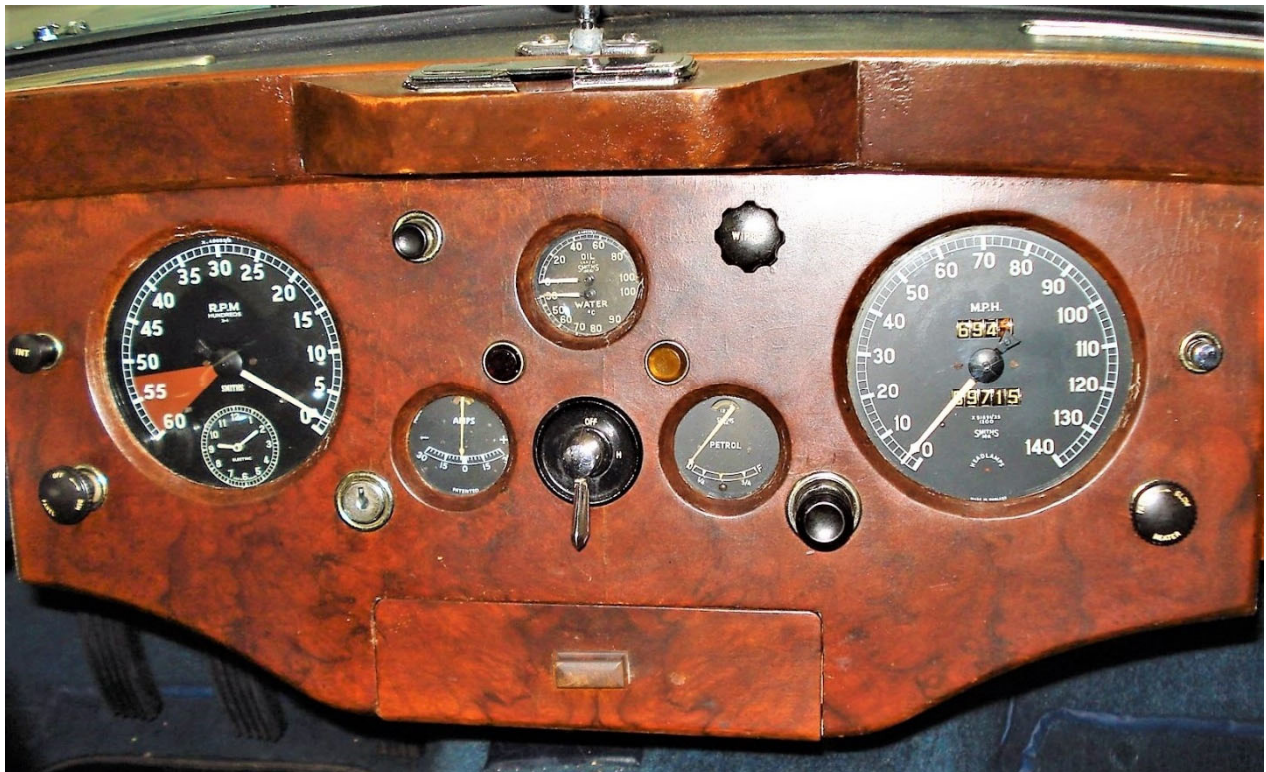
Instrument Panel Assembly from a June 1953 DHC, typical of all 'Later FHC/DHC' XK120 (photo supplied by Cliff Lewis) — see text and NOTES below regarding detail of the gauges, switches and warning lights, and any variations.

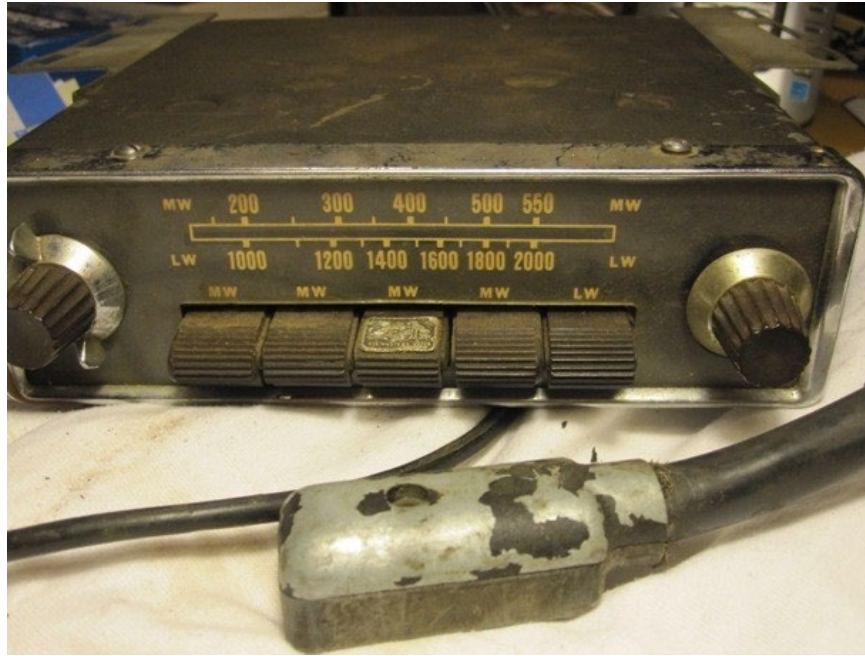
Early C.4063 car radio assembly Radiomobile model RP.100, with "His Master's Voice" on the middle button.

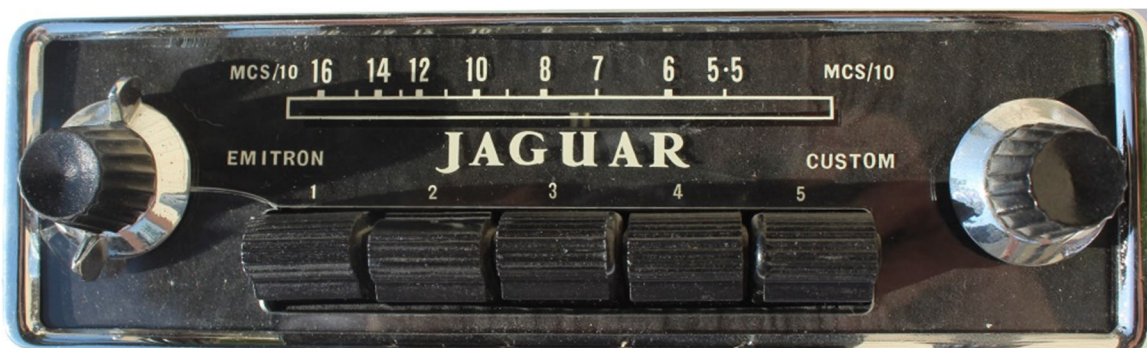
Later C.5379 Car Radio Assembly example Radiomobile model RM.4202 rebranded EMITRON as supplied for aftermarket use in North and South America only (but not the UK and all other markets). (Picture of the author Bob Sheridan's 1952 XK 120 OTS, chassis no. 672233)

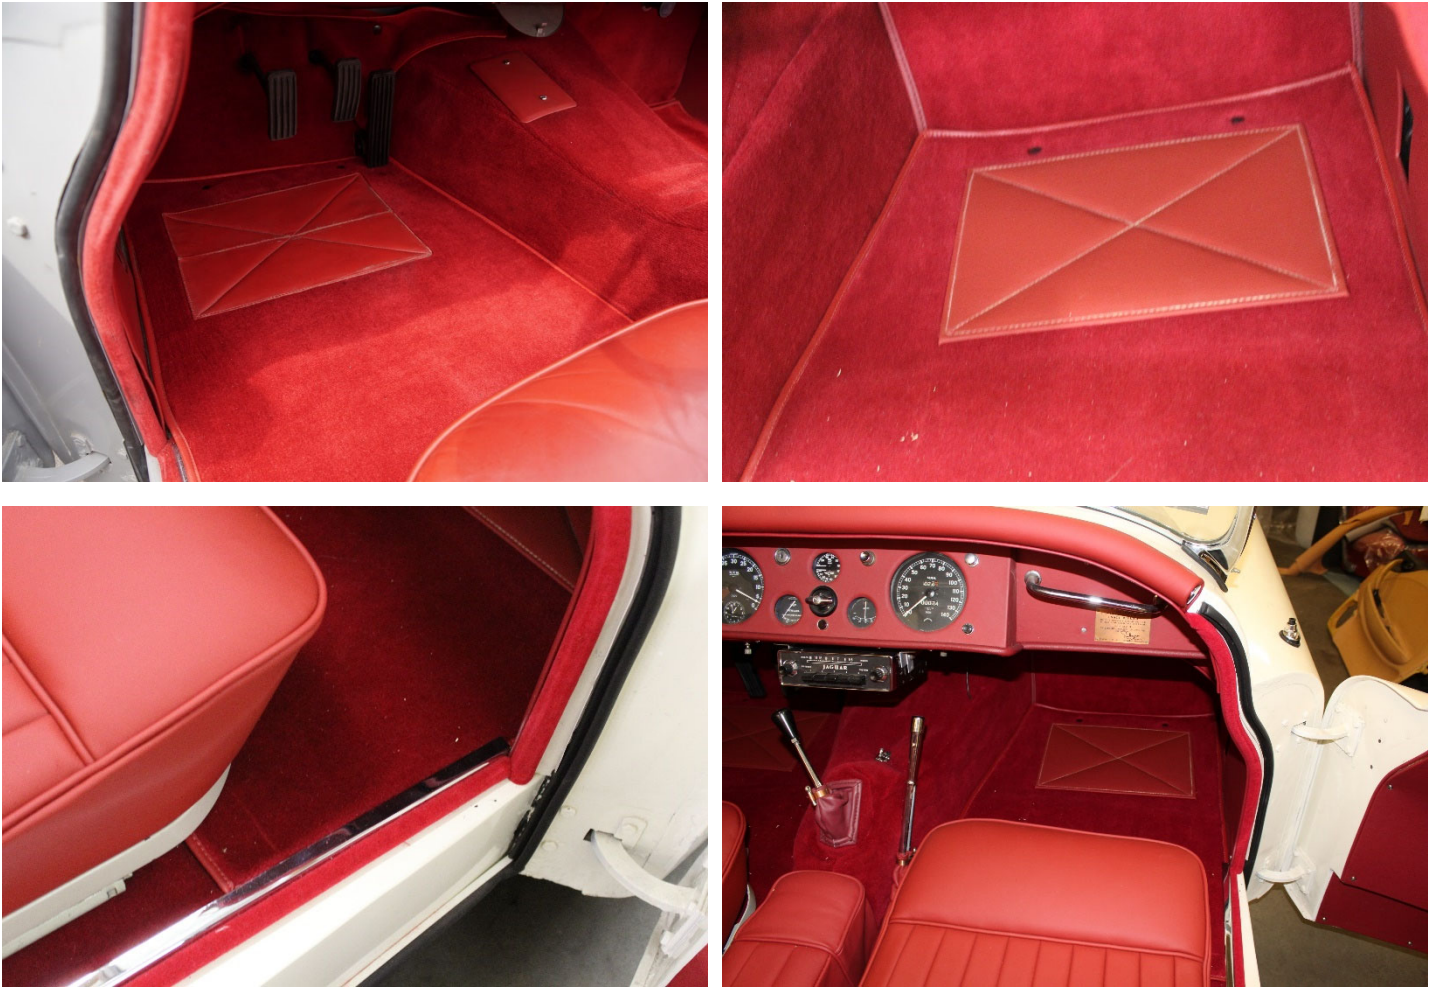
- Factory records advise that for a set of steel-bodied OTS carpets, some **20** ‘Durable Dot’ button-head ‘snap’ fasteners are used, and these are positioned approximately as shown on the main illustration above. It is noted however that the ‘Durable Dot’ fastener shown on the outside-forward edge of both MAIN FLOOR Carpets, is often cited as not being included, given the additional securing by the seat-runners. Accordingly, either a **20** or **18** ‘Durable Dot’ fasteners configuration is considered to be authentic.
- All early steel bodied OTS up to sometime during 1952, used Durable Dot fasteners with their ‘button-head’ **Chromium** plated. From sometime in 1952 onwards, all later OTS had the ‘button-head’ **Black** enameled. (The exact demarcation date is unknown and indeed may have overlapped during 1952).

NOTE: All Carpet dimensions quoted are obtained from the factory build-sheet records, but are noted as being the raw material dimensions, before the Carpets are cut to shape and Rexine binding stitched in place.

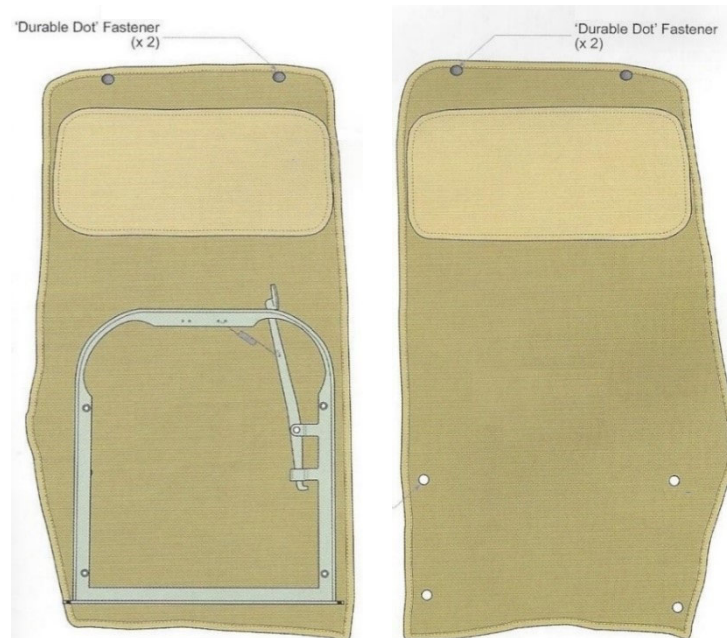
*Indicative Illustration of two (of the five) CARPETS, typical of all XK120 FHC and DHC, but refer to text.
(Illustration used by permission from Bernard Viart, from his book XK 120 Explored, published by PJ Publishing Ltd).*

- Similarly, the MAIN Floor Carpets are found to have only 4 (2 each) button-head 'snap' fasteners being used, and these are positioned as shown in the above illustration.

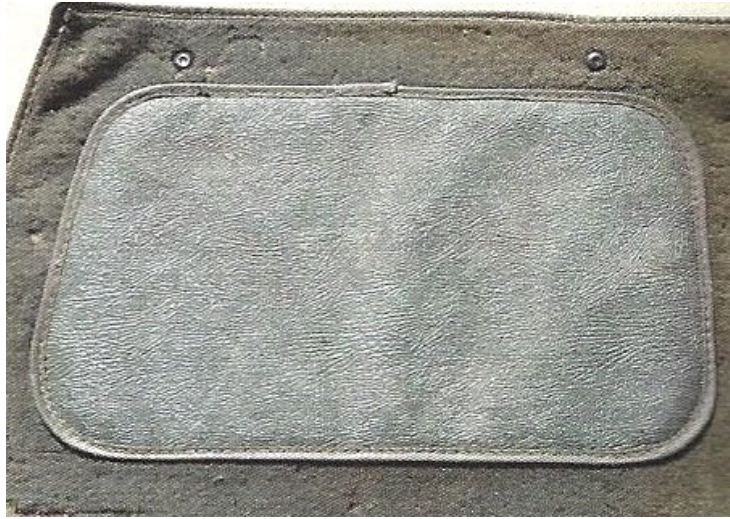
Later OTS Heel Pad. (Photo © Copyright 2002 by Urs Schmid.)

- The HEEL PADS were made of a single piece of HARDURA, approximately 14¼" x 8¼" (for OTS), but with all four corners now rounded. The HARDURA piece was then edged with stitched over REXINE tape
- Factory records have yet to be found that confirms the size of these HARDURA Heel Pads for FHC and DHC but are believed to be 14¼" x 8¼", thus wider and shorter, and are similarly edged in REXINE.
- The HARDURA edged REXINE Heel Pad assembly is then stitched in position onto its relevant MAIN FLOOR carpet, just within its rounded-corner perimeter. There is no additional diagonal stitching.

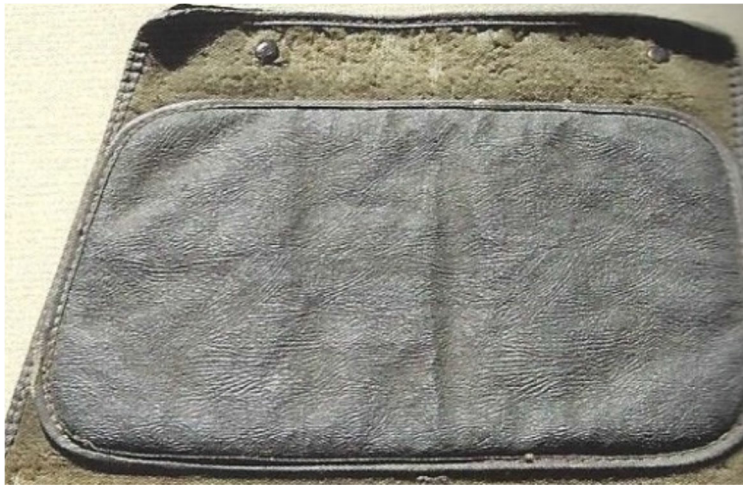
Later FHC and all DHC Heel Pad. (Photo © Copyright 2002 by Urs Schmid.)

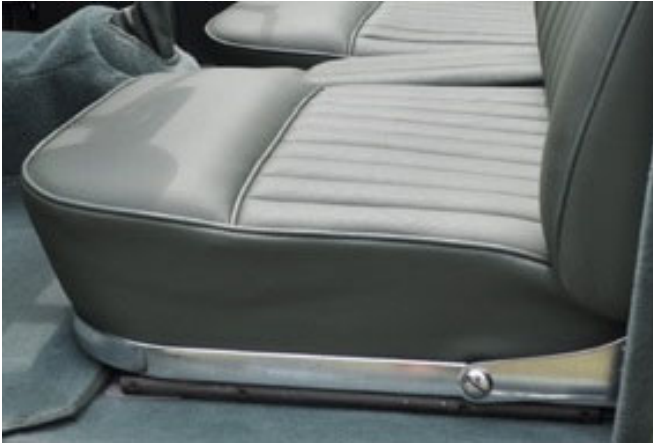
Chrome-plated seat frames.

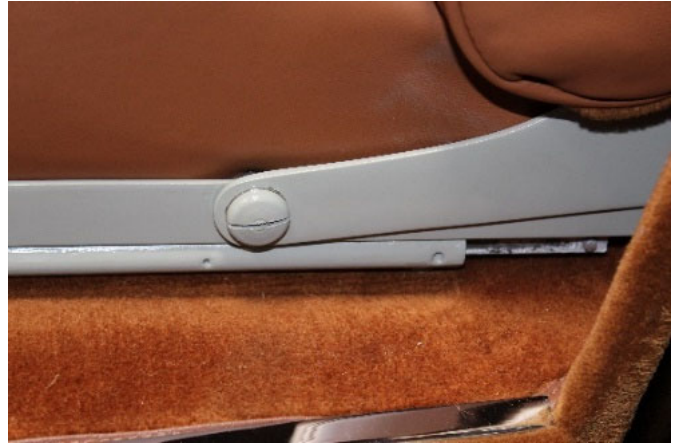
Seat frames painted greenish-grey.

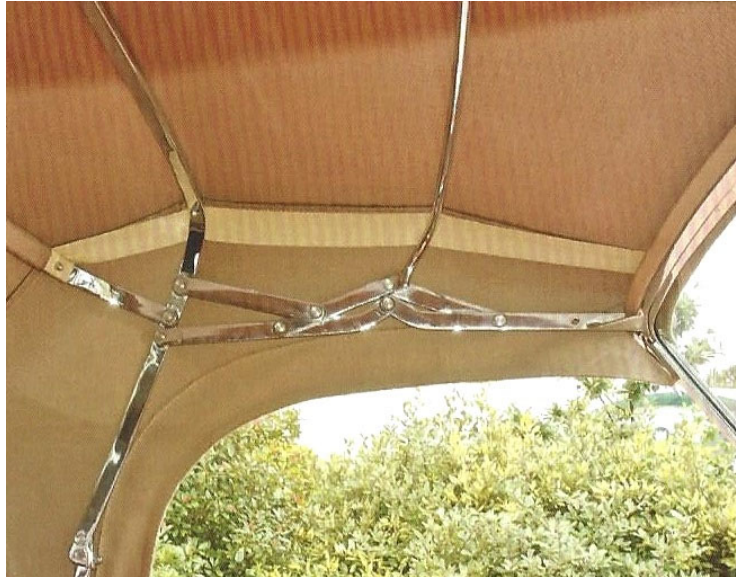
BD.3317 style-1 hoodsticks are chrome-plated and are used with the 'short hood' on the alloy and earliest steel bodied OTS cars.

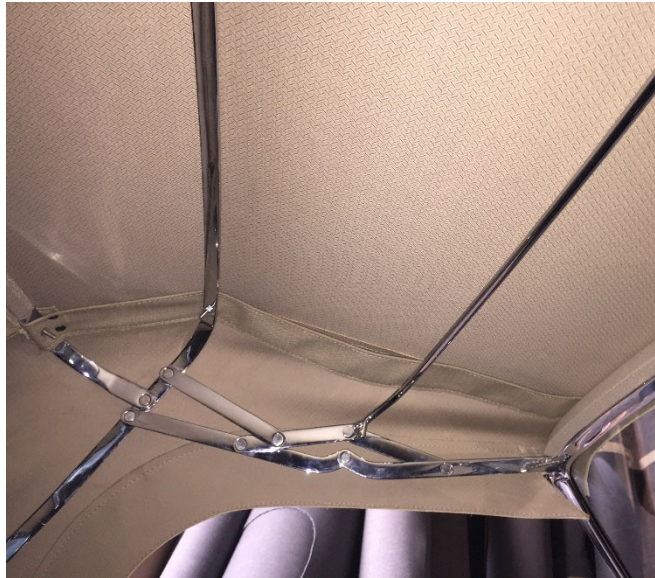
BD.4727 style-2 hoodsticks are chrome-plated and are used with early steel bodied OTS cars until mid-1951.

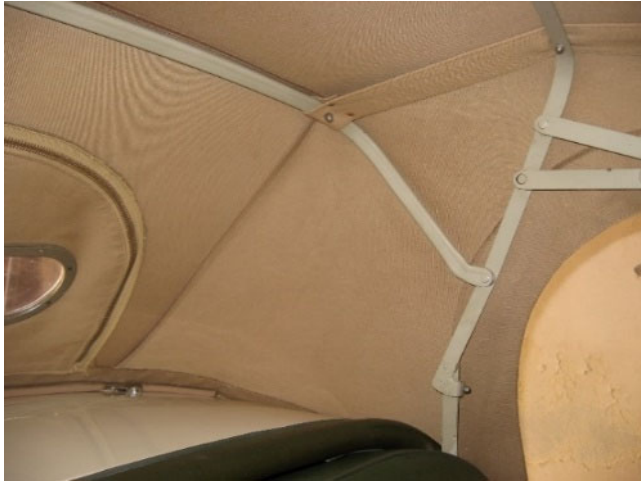
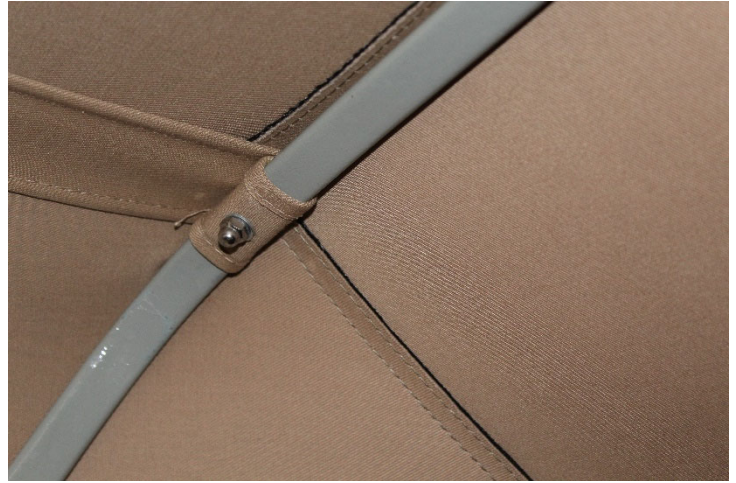
BD.5848 Style-3 hoodsticks are used with the longer hood on later steel-bodied OTS cars.

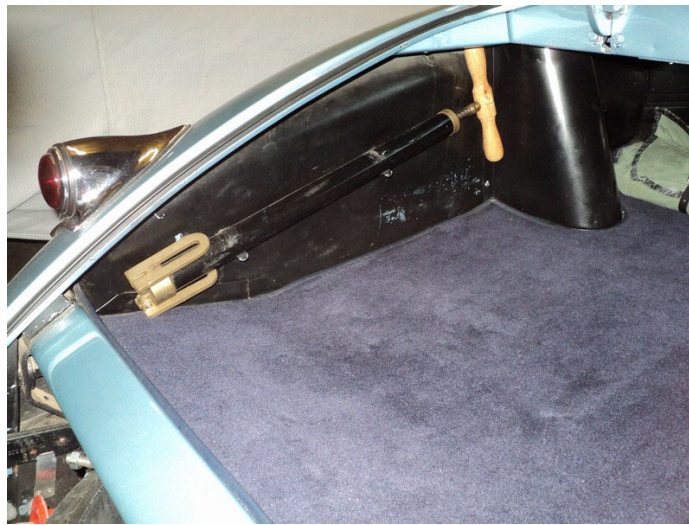
*Alloy cars and early steel-bodied cars, until end of 1950, had the tyre pump on left-hand side as pictured above.
Alloy cars and early steel-bodied cars, until end of 1950, had the tyre pump clipped onto the left-hand side panel as pictured above.
(NOTE, pictured tyre pump with brass feet is a reproduction)*

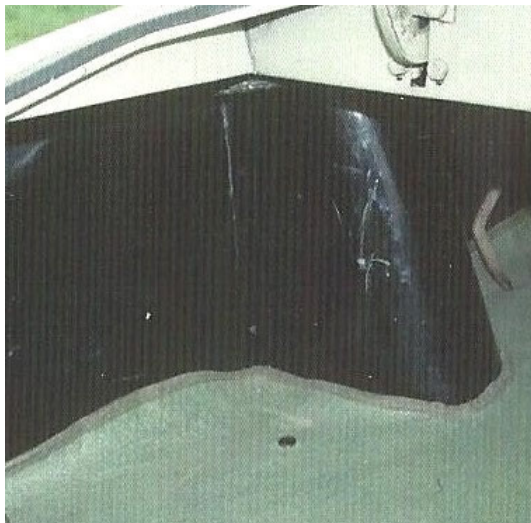
Early steel-bodied car, painted semi-gloss Black.

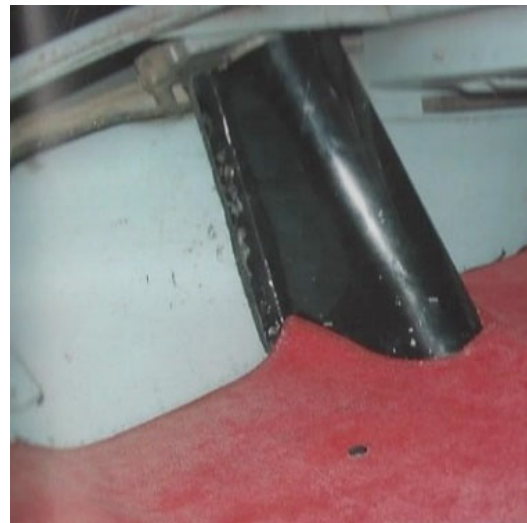
*Later steel-bodied car, painted body color. Photo ©
Copyright 2002 by Urs Schmid.*

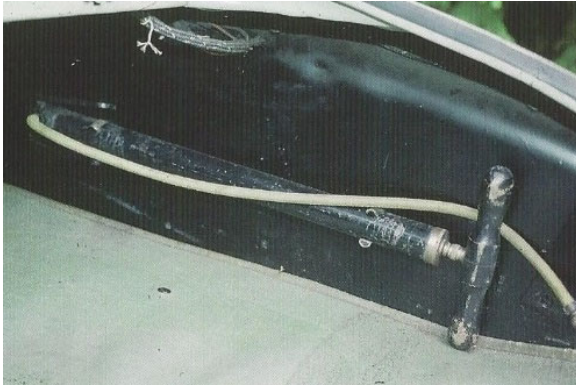
Early steel-bodied car.

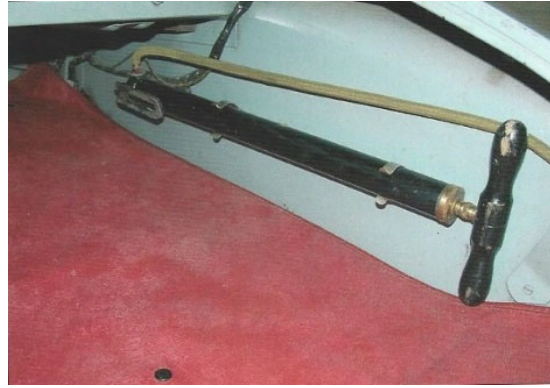
Later steel-bodied car.

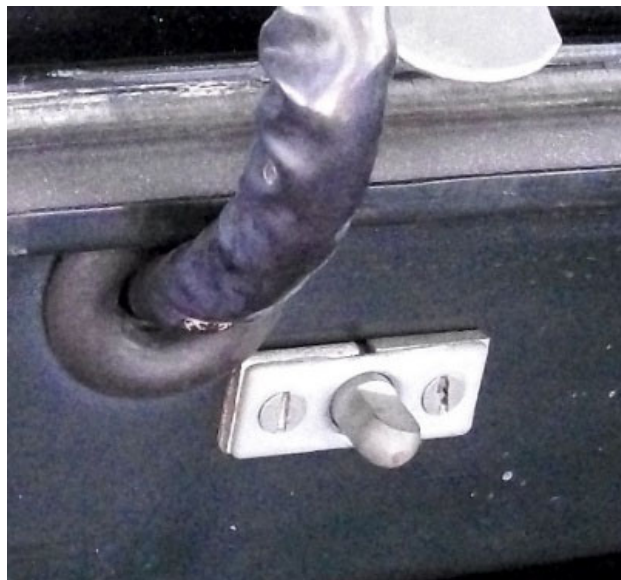
- The boot wiring harness is protected by a black vinyl or PVC type material conduit.
- The boot light switch may be EITHER chrome-plated or a dull, cadmium-plated finish.

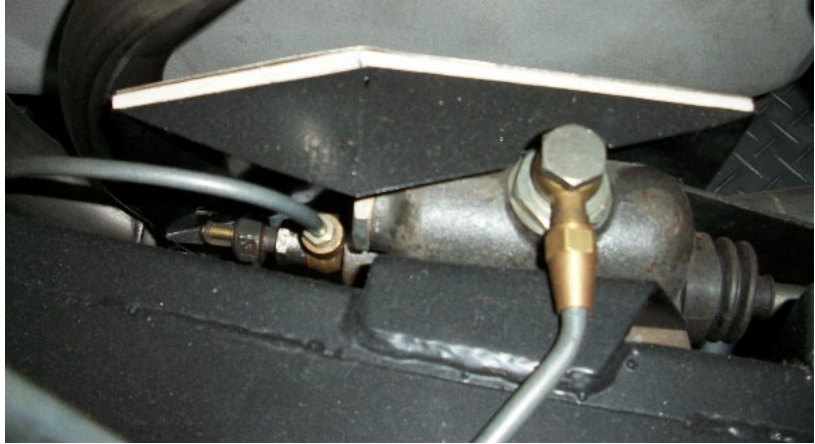
Brake master cylinder assembly, stop light switch fitted to the front, heat shield and supply line coming from the supply tank assembly above.

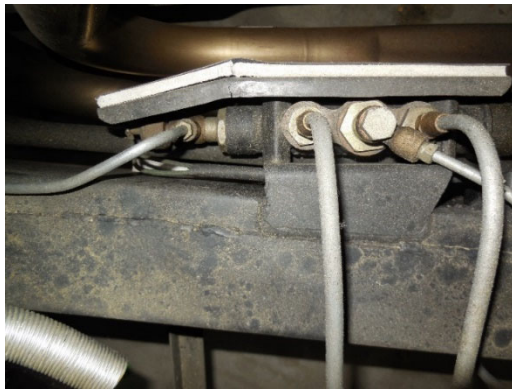
Photo of an incorrect LHD Dual Master Cylinder arrangement, with the Light Switch mounted at the front (as is the case for RHD), and not correctly on top as shown in adjacent photo.

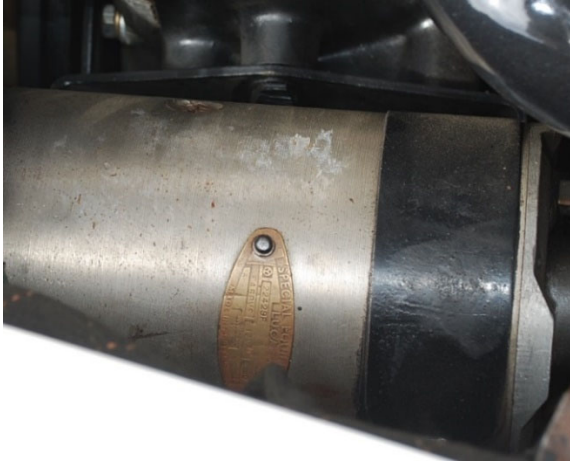
Generator body 'electroless-nickel' plated, with black paint cover-band.

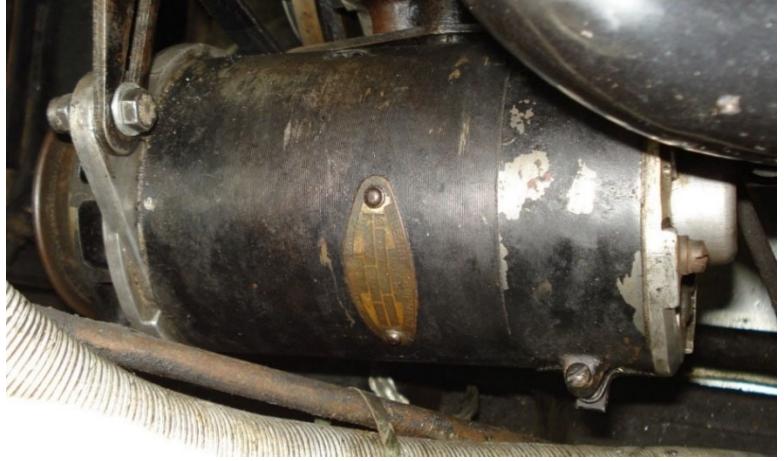
1953 generator body and cover-band painted black. (Cliff Lewis photo)
