JAGUAR XK120

JCNA CONCOURS JUDGING GUIDE

CORRECTIONS AND UPDATES

This document contains “corrections and updates” made to the XK 120 JCNA Concours Judging Guide
First Printing in September 2018, approved for “trial use” during 2018 Concours season at the
60th Annual General Meeting (AGM), San Antonio, Texas, March 21 – 25, 2018

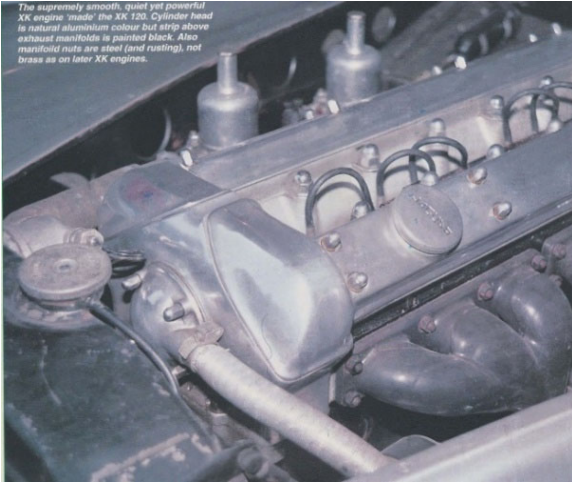
Early cylinder head on Tucker car, chassis no. 670178.

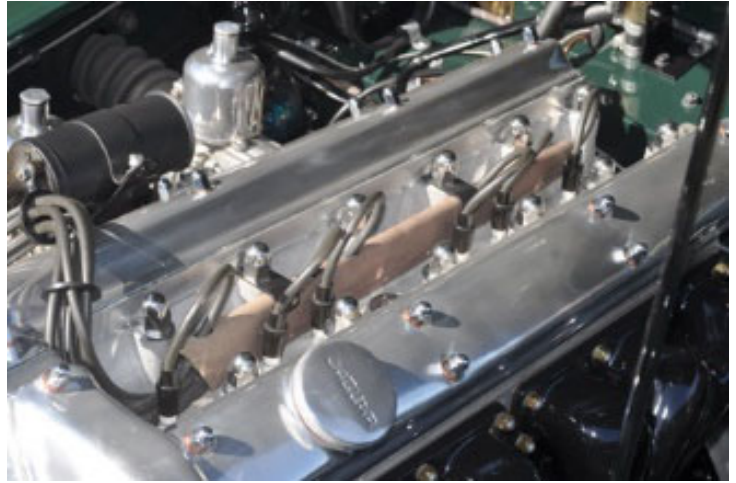
Later cylinder head

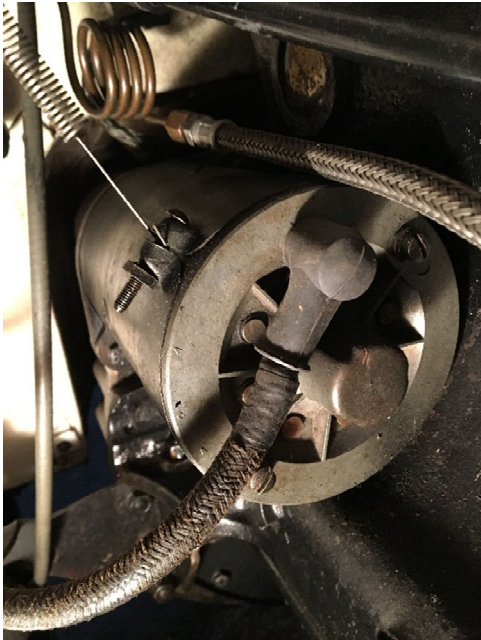
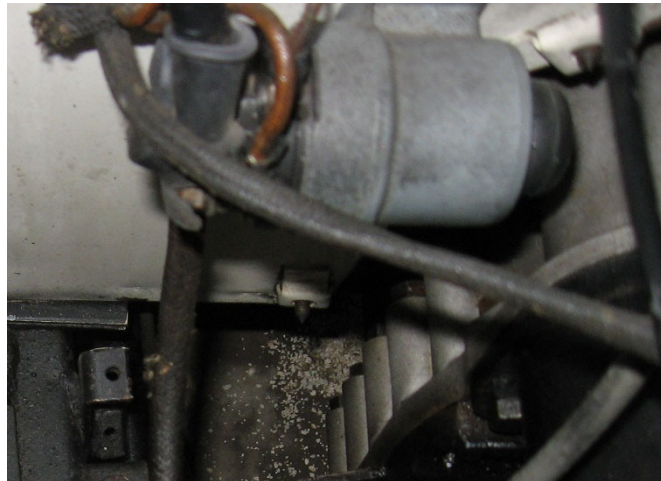
- The starter motor is painted semi-gloss black, with the cast-aluminum end plate left unpainted aluminum.
- The starter motor should have a rubber boot over the electrical cable. (pictured on left).
- The starter solenoid should have a rubber boot on the push-button. (pictured on right)

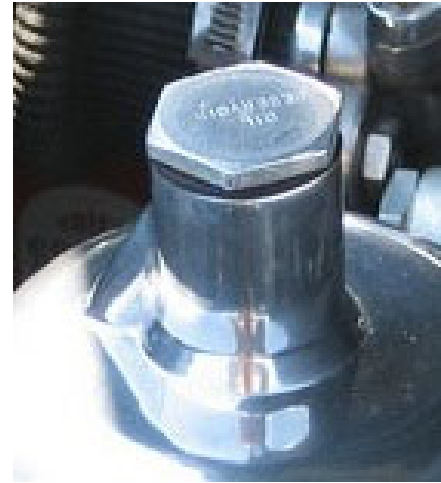
The oil-cap was initially dull-nickel plated, but from 1954 was cadmium-plated, and has stamped in OIL RESERVOIR. The fiber-washer underneath the oil-cap was thin and barely visible, a tan-color initially, but usually black. (NOTE: the rib on the side of neck is an air-vent)

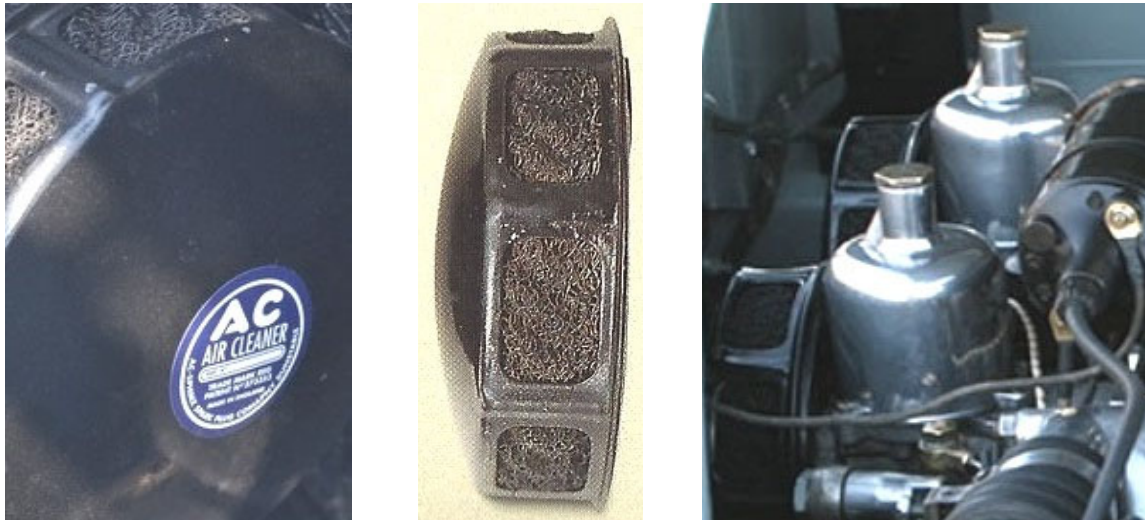
NOTE: From early-1954 onward, a small white on blue, round ‘AC’ sticker is located in the middle of each air cleaner. ‘AC’ stickers found on air cleaners prior to early-1954 are “NON-AUTHENTIC”.

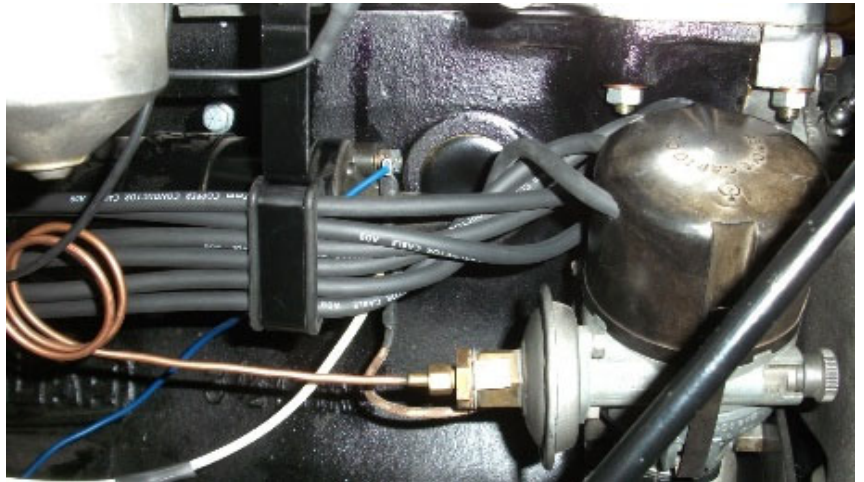
*After exiting the horizontal Distributor Cover, the High-Tension Leads are grouped through a flat and horizontal clip with a rubber grommet. A copper Vacuum Advance Tube is connected to the vacuum-advance unit of the distributor. (NOTE: The white lettering on the high-tension leads, is NON-AUTHENTIC. The flat clip should be horizontally oriented, not vertical as shown. **(NEED A BETTER PICTURE)**).*

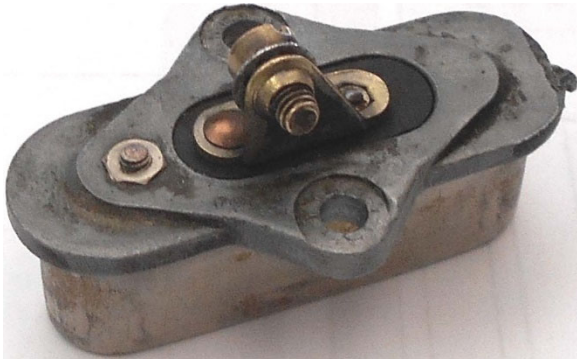
Bottom view of early thermostat switch.

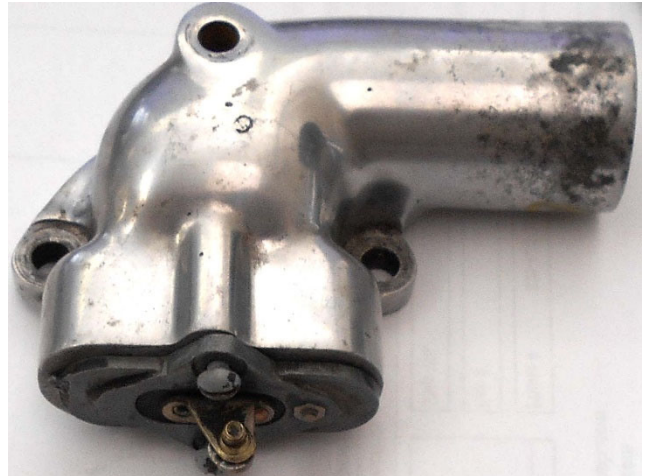
Side view of early water outlet elbow with thermostat switch.

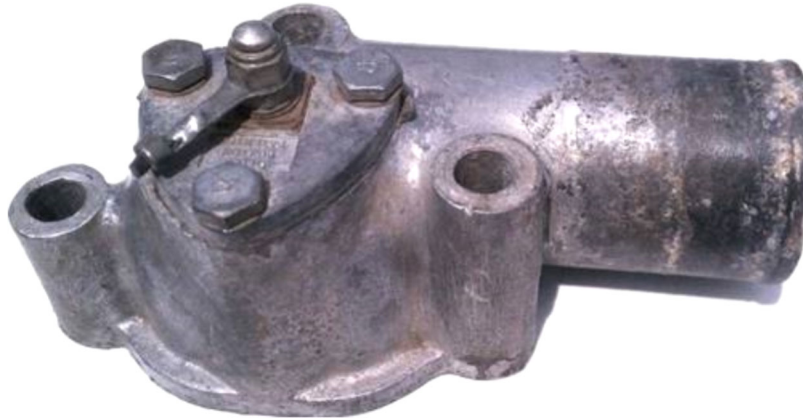
Underside view of later Water Outlet Elbow and second variant C.2474 Thermostat (Otter) Switch, with electrical connection.

- Any one of the three C.2474 OTTER SWITCH variants are accepted as being ‘authentic’ original or replacement parts.
- The three Setscrews are ‘authentic’ if original 3/8”AF hexagon headed as described above, or the later 5/16”AF hexagon headed No.10 UNC setscrews are accepted as being ‘authentic’ replacement parts, if in a matching set of three.

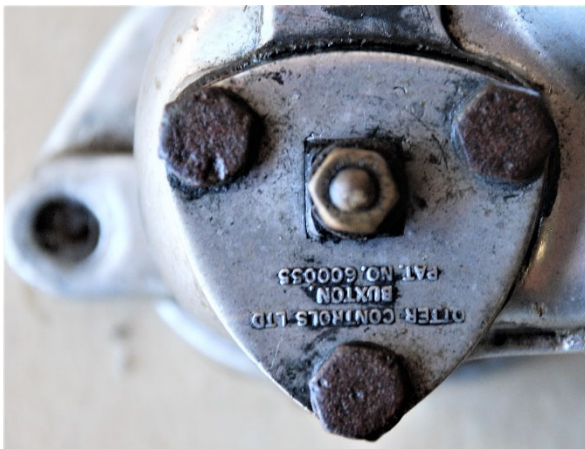
March 1950 onwards, first variant C2474 Otter Switch (cable to the starting-carburettor is removed)

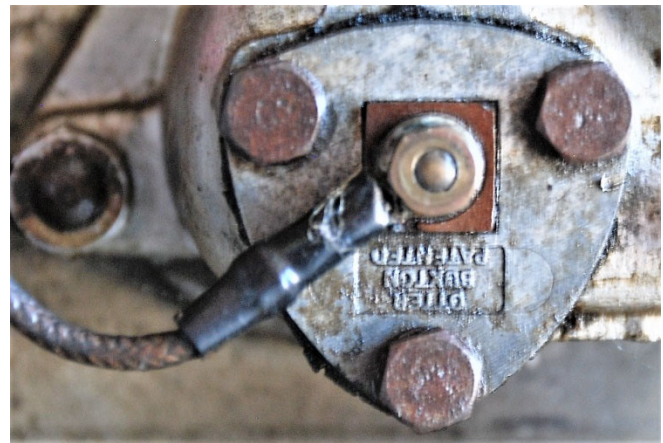
1950/51 onwards, second variant C2474 Otter Switch (cable to the starting-carburettor is connected)
